Test Report

Name of Sample:	CAMERA
Brand Name:	TYCO
Model No.:	ISV-B02M013S-N, ISV-B02M023S-N, ISV-B05M023S-N, ISA-B02M015S-N, ISA-B04M015S-N, ISV-B02M014S-N, ISV-B02M024S-N, ISV-B05M024S-N, ISV-B02M015S-N, ISV-B04M015S-N
Client:	Tyco Safety Products (Shanghai) Co., Ltd.
Manufacturer:	Tyco Safety Products (Shanghai) Co., Ltd.
Test Sort:	Commission Test
Test Item:	IK10

Shenzhen EBO Testing Center

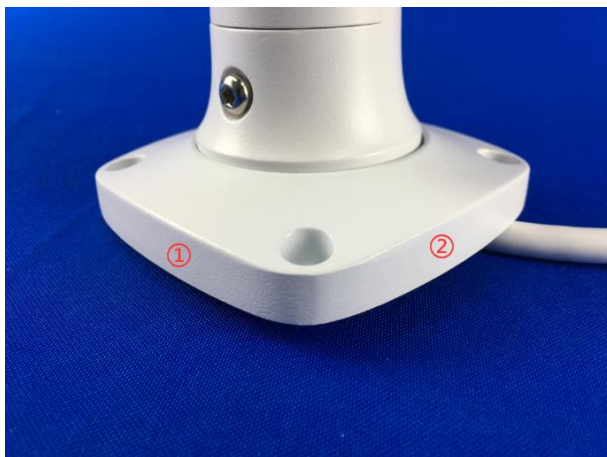
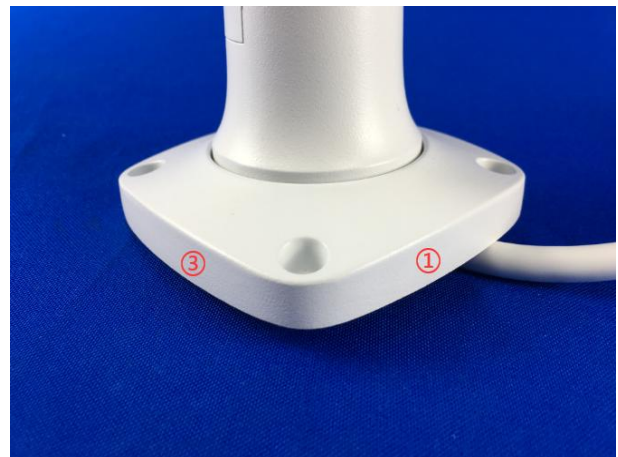
- (1) Place the sample on the ground, drop the pendulum bob which weight is 5kg to impact the sample from a height of 400mm, the impact energy is 20J
- (2) Impact 3 points on the surface of sample each for once

- (3) Examine the appearance of specimen by visual check after this test.

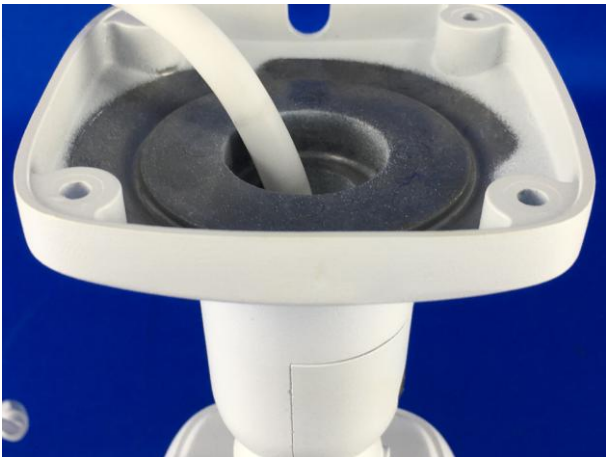
Visual check (Impact point 1)

Check Item Sample No.:	Visual check
1#	After testing, the surface of the sample was not damaged at 3 impact points

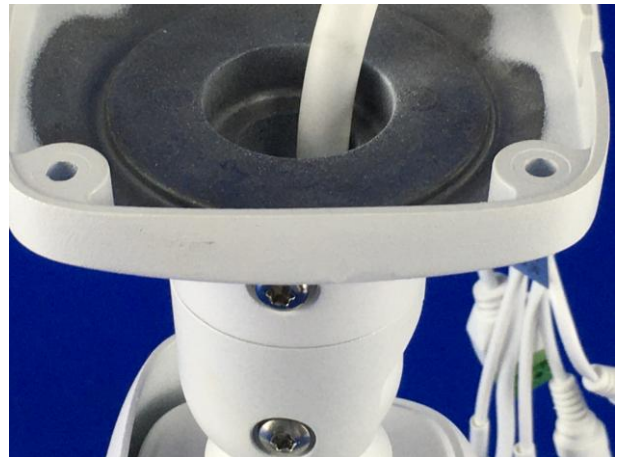
Visual check (Impact point 2)

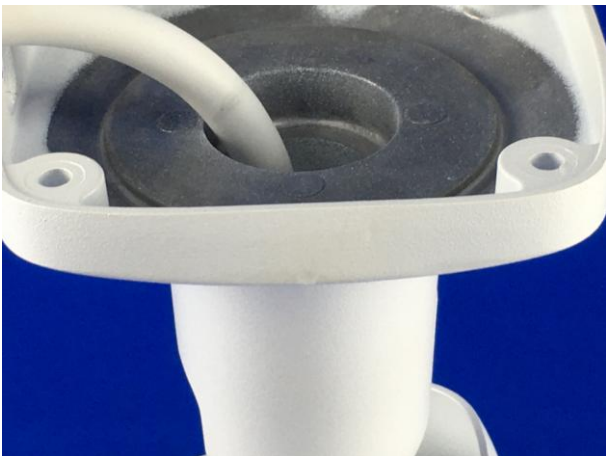
Visual check (Impact point 3)
