# Test Report

<b>Name of Sample:</b>	CAMERA
<b>Brand Name:</b>	TYCO
<b>Model No.:</b>	ISV-V02M013S-N, ISA-V02M015S-N, ISA-V04M015S-N, ISV-V05M023S-N, ISV-V02M014S-N, ISV-V02M015S-N, ISV-V04M015S-N, ISV-V05M024S-N
<b>Client:</b>	Tyco Safety Products (Shanghai) Co., Ltd.
<b>Manufacturer:</b>	Tyco Safety Products (Shanghai) Co., Ltd.
<b>Test Sort:</b>	Commission Test
<b>Test Item:</b>	IK10

## Shenzhen EBO Testing Center

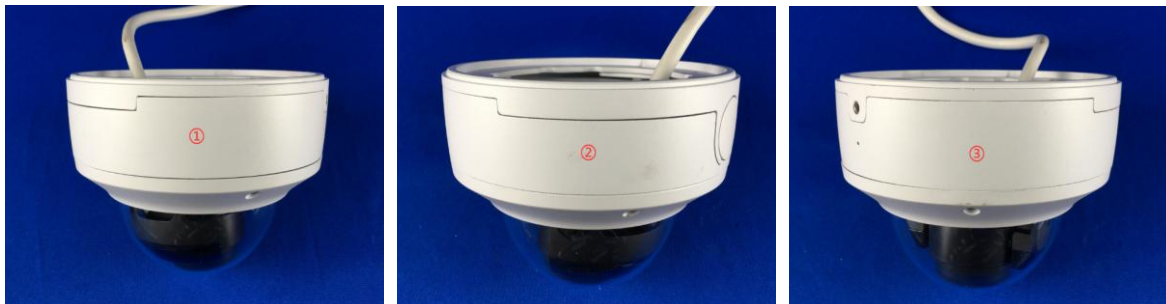
- (1) Place the sample on the ground, drop the pendulum bob which weight is 5kg to impact the sample from a height of 400mm, the impact energy is 20J
- (2) Impact 3 points on the surface of sample each for once

- (3) Examine the appearance of specimen by visual check after this test.

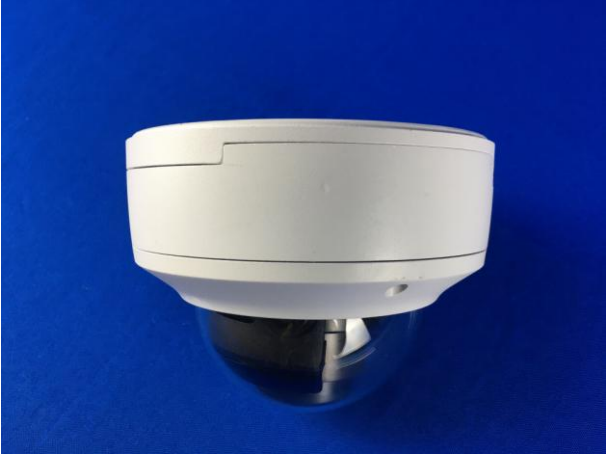
<b>Check Item Sample No.:</b>	<b>Visual check</b>
1#	After the test, all of the 3 impact points had been no broken with appearance.

Visual check (Impact point 1)

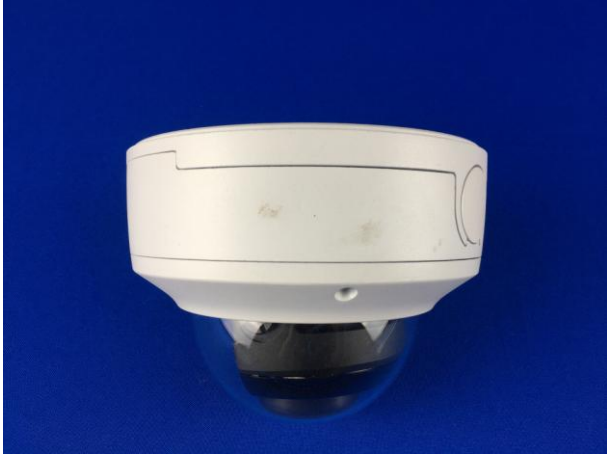
Visual check (Impact point 2)

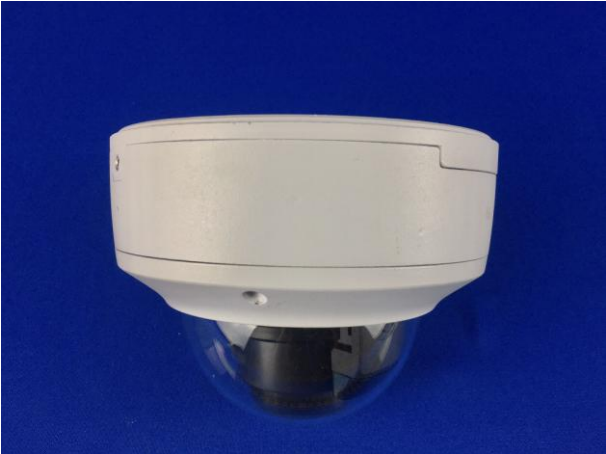
Visual check (Impact point 3)
